1	Christina C. Sharp (State Bar No. 245869)	
2	Jordan Elias (State Bar No. 228731) Adam E. Polk (State Bar No. 273000)	
3	GIRARD SHARP LLP 601 California Street, Suite 1400	
4	San Francisco, CA 94108	
5	Tel: (415) 981-4800 Fax: (415) 981-4846	
	dsharp@girardsharp.com jelias@girardsharp.com	
6	apolk@girardsharp.com	
7	Eric H. Gibbs (State Bar No. 178658)	
8	Dylan Hughes (State Bar No. 209113) Steven M. Tindall (State Bar No. 187862)	
9	Amy M. Zeman (State Bar No. 273100) GIBBS LAW GROUP LLP	
10	505 14th Street, Suite 1110 Oakland, CA 94612	
11	Tel: (510) 350-9700	
12	Fax: (510) 350-9701 ehg@classlawgroup.com	
13	dsh@classlawgroup.com smt@classlawgroup.com	
14	amz@classlawgroup.com	
15	Plaintiffs' counsel	
16		
17		ES DISTRICT COURT FRICT OF CALIFORNIA
18	NORTHERN DIS	
19	I.C. and I.D.) Case No.
20	Plaintiffs,	COMPLAINT AND DEMAND FOR JURY TRIAL
21	V.) DEMAND FOR JURI TRIAL
22	CHART INC.	}
23	Defendant.	}
24		_)
25

I. Tank 4: A Chart MVE Cryopreservation Tank

II. The Defect in Tank 4

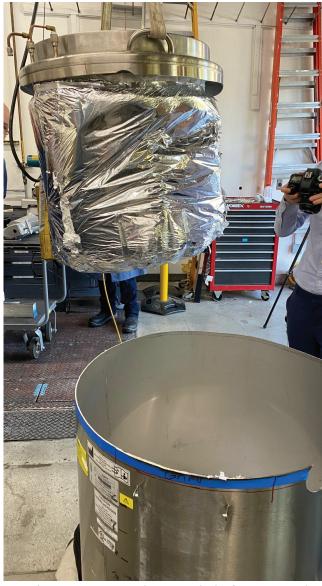
Tank 4's inner vessel suspended after removal from outer vessel (vacuum space was in between)

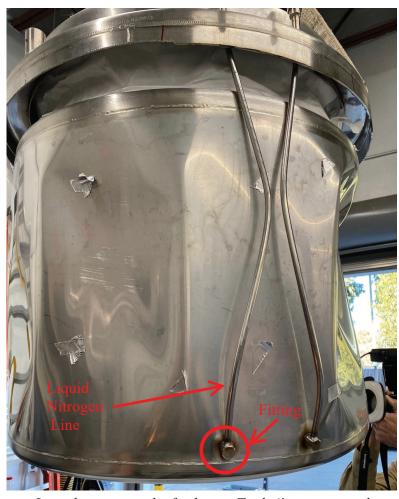
- 23. Tank 4 was only six years old when its vacuum insulation suddenly failed. The reason for the failure was a defective weld near the bottom of the tank's inner vessel.
- 24. Tank 4 was manufactured with a metal tube that is used to refill the tank with liquid nitrogen. The tube ran from the top of the tank, down through the vacuum space between the inner and outer vessel, and then into the inner vessel near the bottom of the tank.
- 25. The picture below was taken after the outer vessel of Tank 4 was removed. The liquid nitrogen tube is on the left and the red circle shows where it connects to the inner vessel through a fitting.

Liquid nitrogen tube feeds into Tank 4's inner vessel

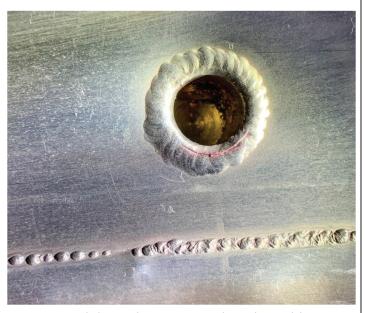
- 26. The fitting is held in place by a single weld on the inside of the inner vessel wall. That weld cracked, as shown in the images below. The image on the left was taken after application of Snoop Liquid Leak Detector. The bubbles indicate a leak. After multiple inspections of the tank by all interested parties, including leak testing by Chart, no other leak has been detected.
- 27. The image on the right is the same weld, this time after using Magnaflux Spotcheck liquid dye penetrant. The fact the red dye penetrant remained after the surface was wiped clean is indicative of a crack.

Red dye indicates a crack in the weld

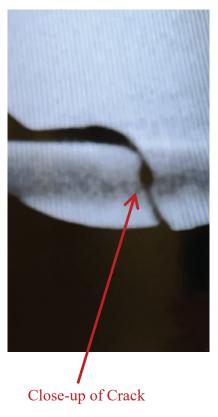
28. The presence of a crack was further verified through CT scans of the weld, shown below. The image on the left is a cross-section where the fitting connects to the tank's inner vessel and the image on the right is a close-up of the weld. The CT images shows a clear crack through the weld.

29. The CT scans also indicate why the weld likely failed. The weld was very thin in the area of the crack—only a fraction of the thickness of the tank wall.

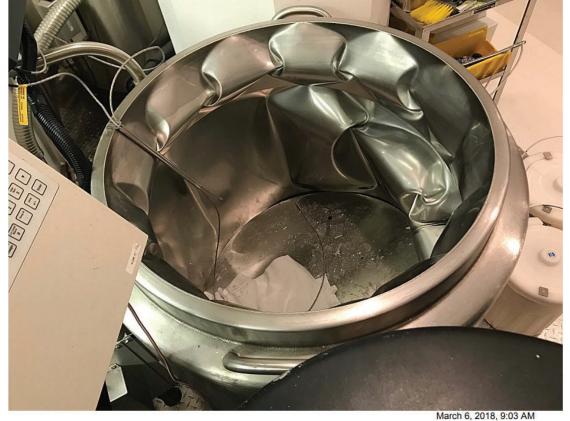
- 33. The crack and accompanying leak of liquid nitrogen into the interstitial space both destroyed the vacuum insulation that allowed the inner vessel to stay cold and exerted significant pressure on the space between the tank's inner and outer vessel. The inner vessel gave way and crumpled. The following image was taken approximately 36 hours after the PFC embryologists discovered the Tank 4 failure and moved the affected eggs and embryos to another tank.

Tank 4 after the incident

34. This dramatically imploded tank is yet another indication of a cracked failure. As part of its compliance with the European Union's Medical Device Directive, Chart was required to attempt to identify every way that its cryogenic freezers could theoretically fail. Representatives from Chart's various departments came up with over a hundred potential failure modes. One of them was a cracked weld at the liquid nitrogen fill tube—exactly what expert analysis revealed happened to PFC's Tank 4. If that weld did crack, Chart wrote that the result would be: "Liquid draws into vacuum space, expanding rapidly and causing an inner vessel implosion, total vacuum loss. Loss of function of the freezer."
